UNDERWATER BRIDGE INSPECTION REPORT

STRUCTURE NO. L4870

ROOT RIVER

MINNESOTA DEPARTMENT OF TRANSPORTATION
UNDERWATER BRIDGE INSPECTION

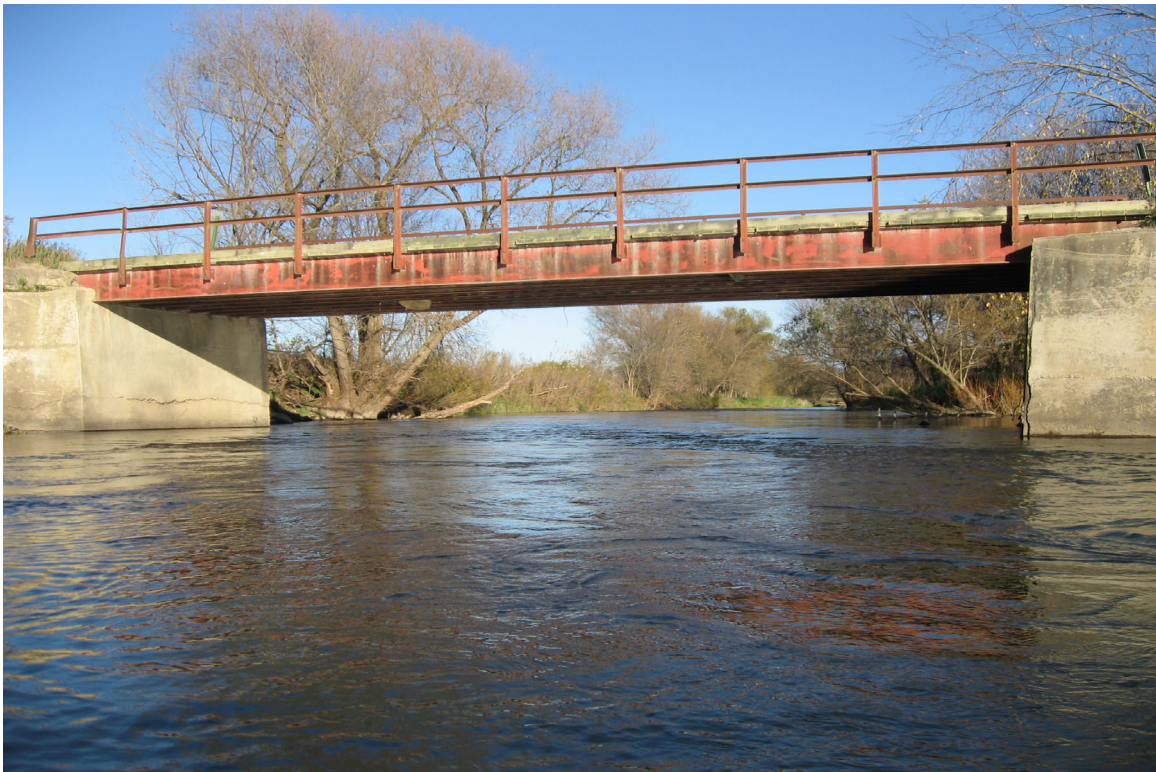
The substructure units inspected at Bridge L4870, the North and South Abutments, were found to be in satisfactory to fair condition below water. Random areas of section loss were observed along the submerged abutment walls with average penetrations of 12 inches and, in some instances, with exposed and corroded steel reinforcing. A section of the concrete facing was undermined along the South Abutment exposing the underlying masonry wall, which was in good condition.
